HYDROGEN EMBRITTLEMENT OF A CYCLICALLY DEFORMED  
HIGH STRENGTH AL ALLOY

R. J. Jacko and D. J. Duquette  
Rensselaer Polytechnic Institute  
Materials Engineering Department  
Troy, New York 12181

December 1976

Technical Report to the Office of Naval Research

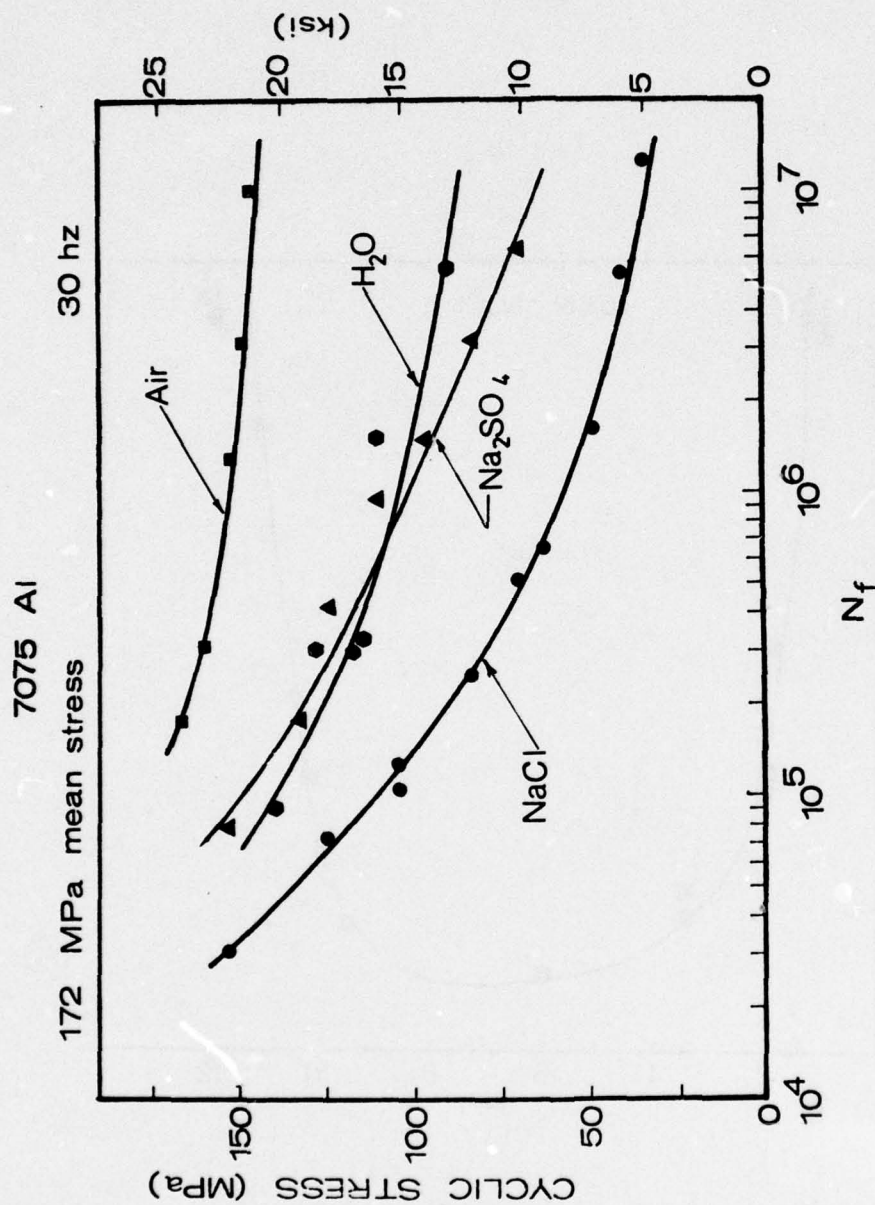
Fig. 1 Fatigue behavior of 7075-T6 Al alloy in air, distilled H<sub>2</sub>O and aqueous solutions of 0.5N Na<sub>2</sub>SO<sub>4</sub> and 0.5N NaCl.

Figure 1 shows the fatigue behavior of the alloy in air, distilled water, 0.5N Na<sub>2</sub>SO<sub>4</sub> and 0.5N NaCl and shows that, except at relatively low applied stresses, H<sub>2</sub>O and Na<sub>2</sub>SO<sub>4</sub> solutions show approximately the same fatigue behavior. Exposure to NaCl solution during cyclic stressing, on the other hand, results in very inferior fatigue resistance with the 10<sup>7</sup> cycle fatigue life corresponding to an applied cyclic stress of only about 35 MPa. A static loading test in NaCl, at an applied stress of about 320 MPa (a  $\sigma_{\text{mean}} + \sigma_{\text{cyclic max}}$  of this magnitude would result in  $N_f = 3 \times 10^4$  cycles) showed no evidence of cracking for a period greater than 200 hours.

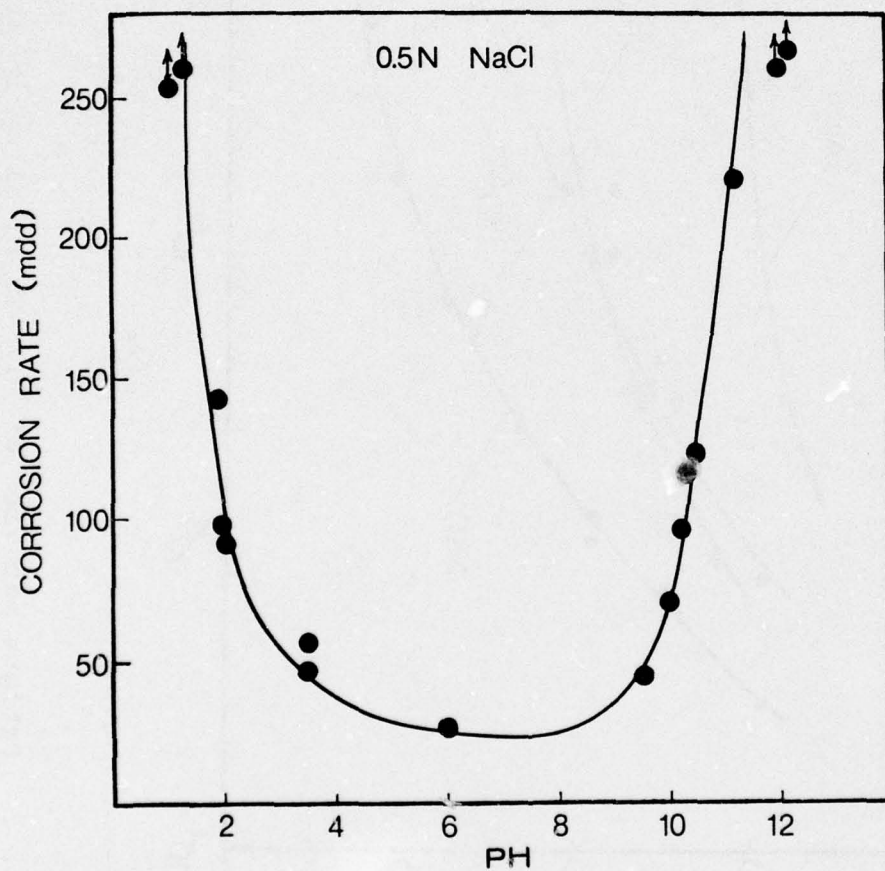
Fig. 2 The effect of pH on general corrosion of unstressed 7075-T6 alloy in aqueous 0.5N NaCl solution (1mdd = 2cm/yr overall penetration).

Figure 2 shows the results of corrosion tests on 7075-T6 aluminum as a function of pH (controlled by NaOH or HCl additions) and indicates a minimum in corrosion rate in the pH 6-8 range. This data is similar to that reported for pure aluminum<sup>10</sup> in H<sub>2</sub>O + H<sub>2</sub>SO<sub>4</sub> or NaOH. Except that for the pure metal, the lowest corrosion rate has been reported to approach zero and, in general to be considerably lower for all pH's.

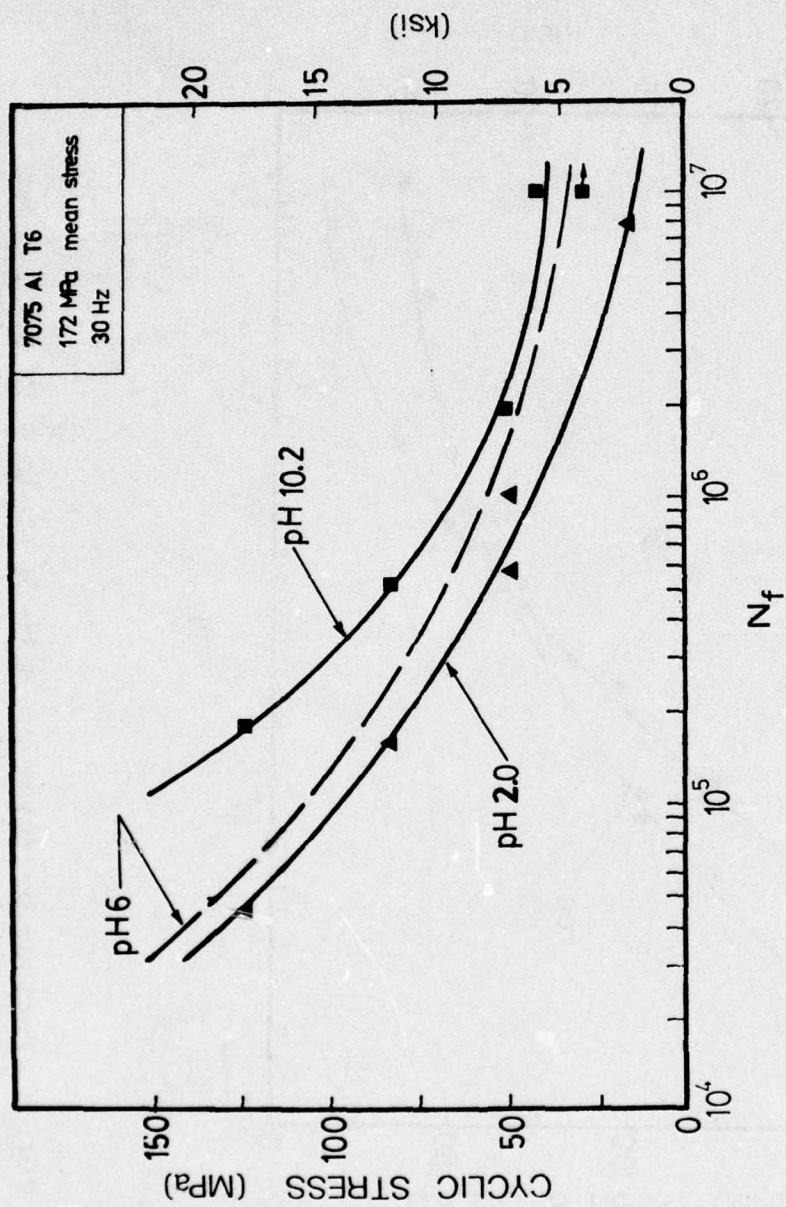
Fig. 3 Fatigue behavior of 7075-T6 Al in 0.5N NaCl solutions of pH 2 and pH 10.2; pH 6 data is repeated from Fig. 1.

Figure 3 shows the S-N behavior for the alloy in a neutral solution and at pH 2 and 10.2 where the overall corrosion rates are approximately equal (about 100mdd). The data of Fig. 3 show that there is not a direct correlation of fatigue behavior with overall corrosion rate, pH 2 solutions reducing the  $10^7$  cycle fatigue limit to a value of about 15MPa. Additionally, there is a divergence of the data at higher applied stresses with the pH 10.2 solution showing longer lines than either the pH 6 solution or the pH 2 solution. At low applied cyclic stresses the pH 6 and pH 10.2 solutions produce approximately the same fatigue resistance while the pH 2 solution shows an almost constant percentage decrease in fatigue resistance when compared to the neutral solution. In an earlier paper, it was suggested that the reduction in fatigue resistance of high strength aluminum alloys was associated with hydrogen (which was produced by selective corrosion in the vicinity of non-metallic inclusions). The pH results also suggest a hydrogen interaction since pH 2 solutions result in lower fatigue resistance. In order to test this hypothesis, fatigue curves were generated for specimens which were maintained at a potential of about 1300 versus the saturated calomel electrode (about 600 mv cathodic to the corrosion potential). The cathodic current density at this potential corresponded to  $\approx 0.7 \text{ ma/cm}^2$  which could be expected to produce  $\approx 10^{15}$  molecules  $\text{H}_2/\text{cm}^2\text{sec}$ . (assuming that the measured

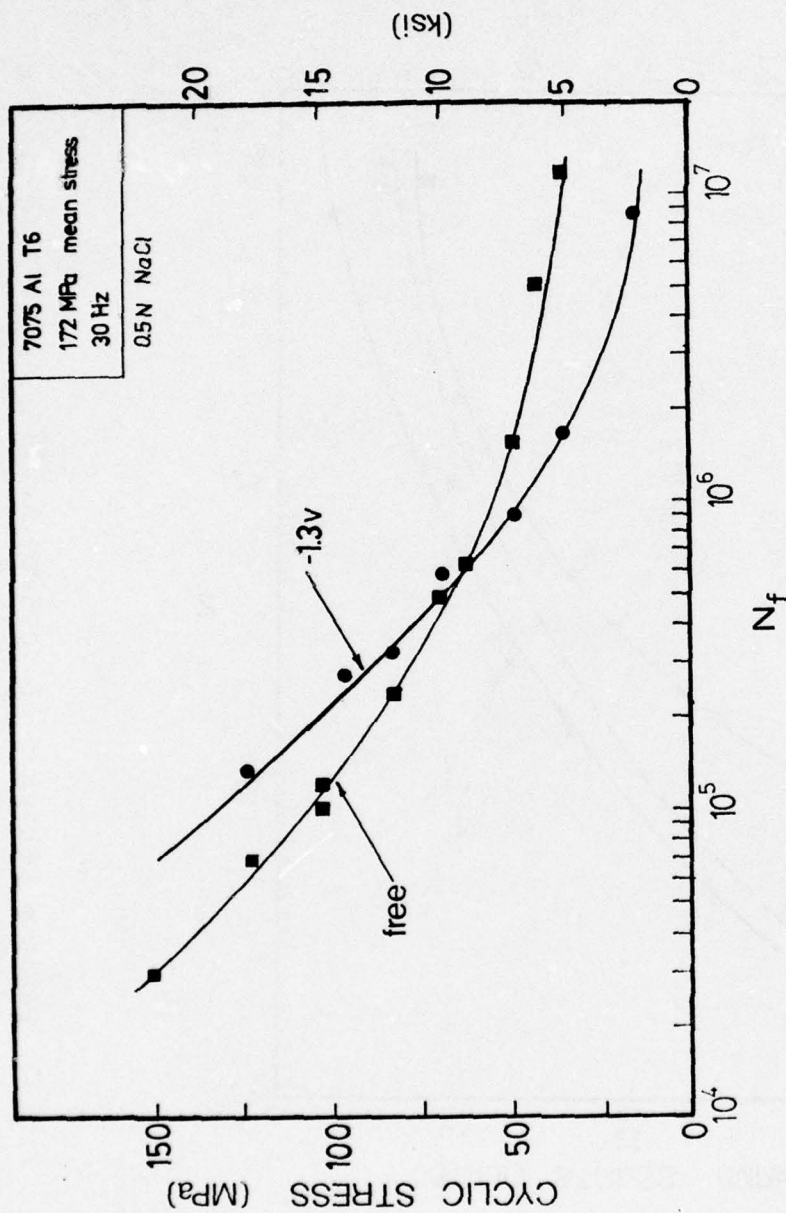
Fig. 4 Fatigue behavior of 7075-T6 Al in 0.5N NaCl under conditions of cathodic charging at  $\phi_c = -1300$  mv vs.SCE.

current is only used to generate  $H_2$ ). Figure 4 shows that, at high applied cyclic stresses cathodic charging results in an increase in fatigue resistance, while at lower applied stresses, cathodic charging results in decreased fatigue resistance with the  $10^7$  cycle fatigue limit reduced to a value of only  $\approx 13$  MPa. Charging at lower potentials does not appreciably affect fatigue resistance, although charging at higher potentials (less hydrogen evolved) results in some cathodic protection, a maximum in protection being observed at -900 mv vs. the saturated calomel electrode. Anodic polarization results in a still larger reduction in fatigue resistance (Fig. 5). The addition of a hydrogen atom recombination poison (10 ppm As) to the sodium chloride solution also results in a small reduction in fatigue resistance (Fig. 6).

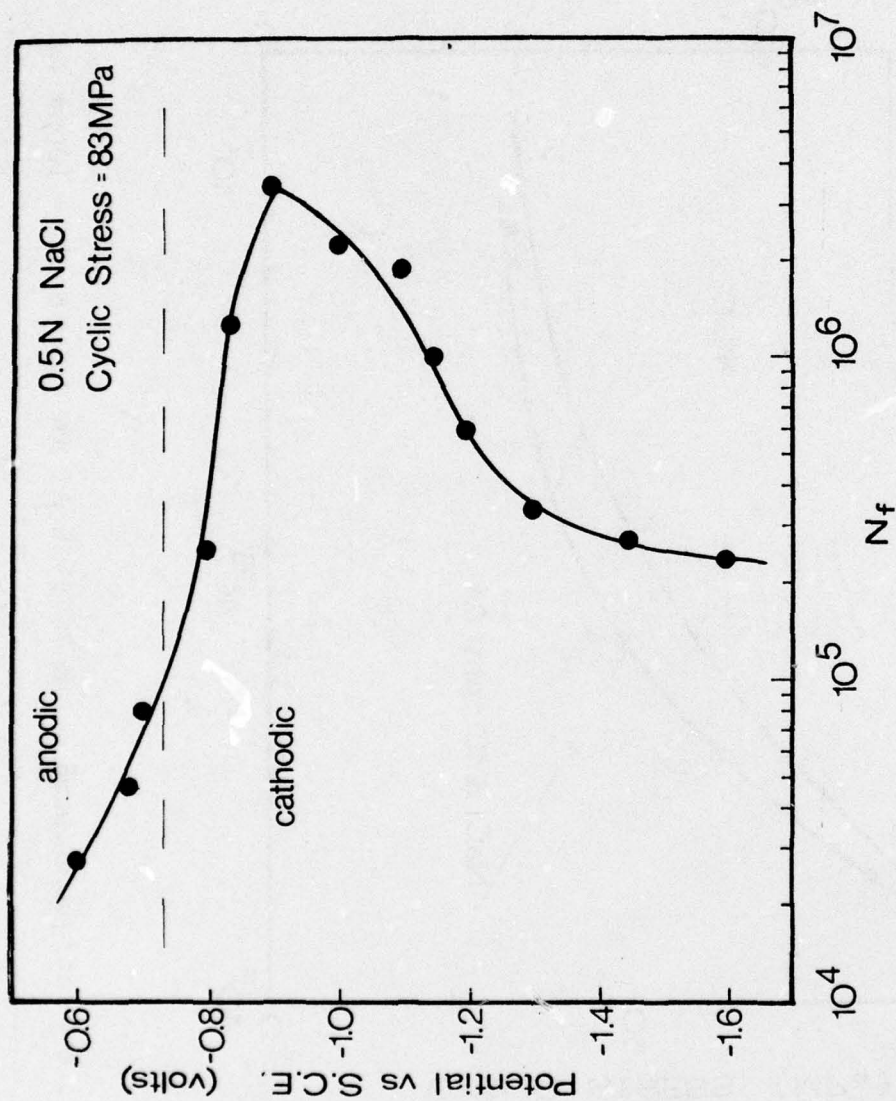
Fig. 5 Fatigue life of 7075-T6 Al in 0.5N NaCl under conditions of cathodic charging,  $\sigma_{\max} = 255$  MPa.

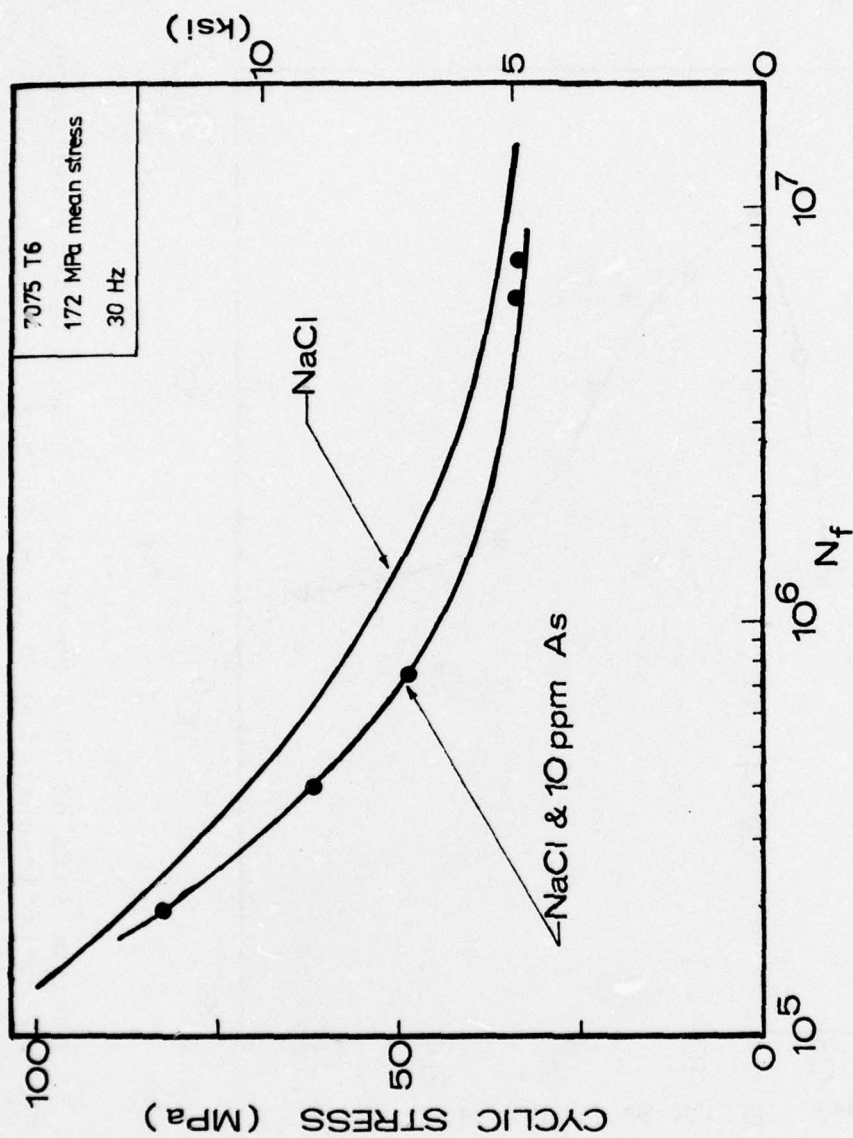
Fig. 6 Fatigue behavior of 7075-T6 Al in 0.5N NaCl + 10ppm As.

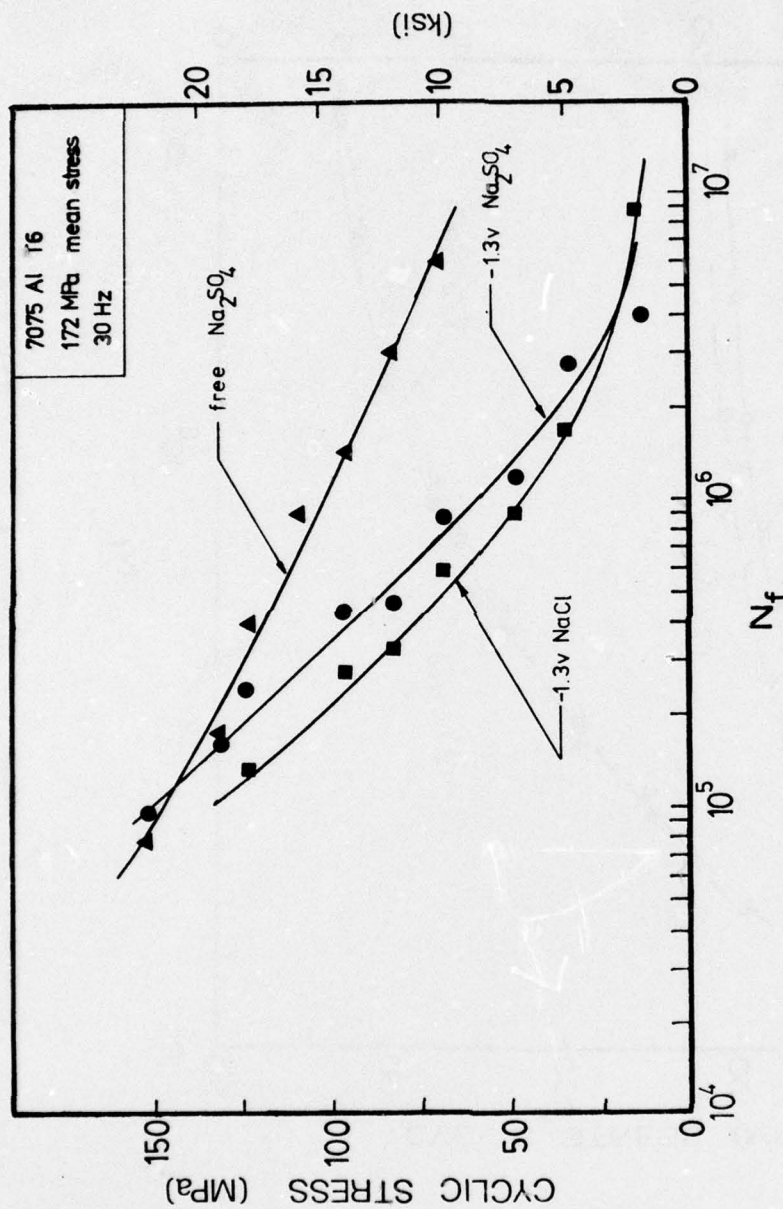
Fig. 7 Fatigue behavior of 7075T6 Al in 0.5N  $\text{Na}_2\text{SO}_4$  under conditions of cathodic charging at  $\phi_c = -1300$  mv vs. SCE compared to free corrosion in 0.5N  $\text{Na}_2\text{SO}_4$  and under conditions of cathodic charging in 0.5N NaCl at  $\phi_c = -1300$  mv vs. SCE.

Cathodic charging of the alloy exposed to neutral 0.5N  $Na_2SO_4$  results in a large reduction in fatigue resistance in a similar manner to cathodic charging in NaCl solution (Fig. 7). At stresses in the vicinity of the  $10^7$ -cycle fatigue limit, cathodic charging in sulfate results in virtually the same fatigue resistance as is observed in chlorides. At higher stresses, however sulfates are slightly less aggressive than chlorides.

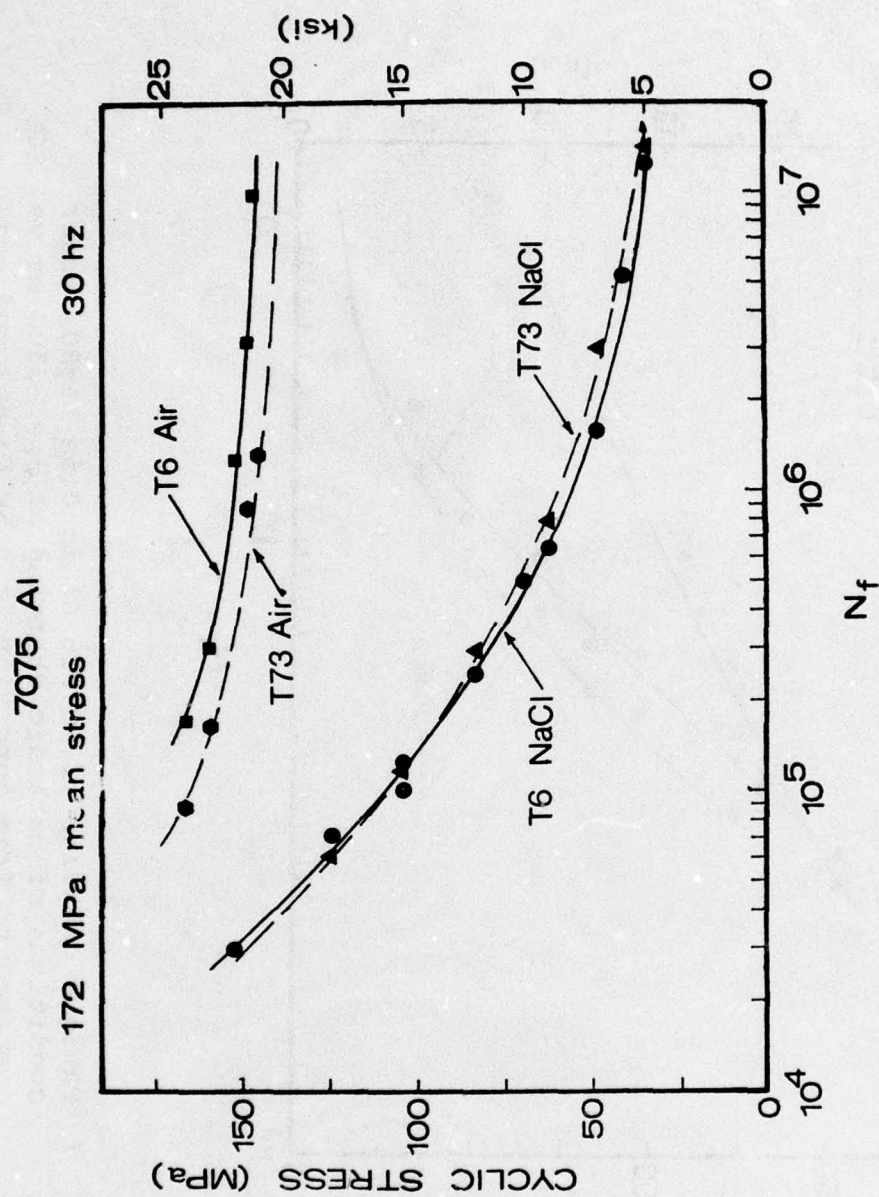
Fig. 8 Fatigue behavior of 7075-T73 Al in air and in 0.5N NaCl compared to behavior of 7075-T6 Al.

In addition to experiments on the 7075 alloy in the T6 condition, a limited number of experiments were conducted on specimens in the T73 condition, a heat-treatment which has been shown to be more resistant to stress corrosion cracking. Figure 8 shows the results of these experiments with an expected slight

slight decrease in fatigue resistance in dry air (YS and UTS are lower for T73 than they are for the T6 heat treatment). In aerated 0.5N NaCl solution, however, there is no appreciable difference in fatigue resistance.

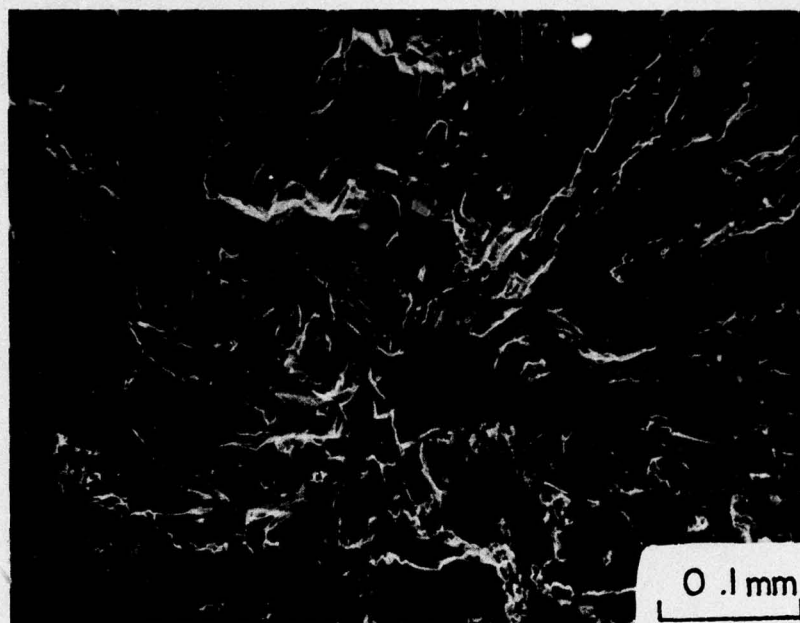
Fig. 11 Fracture surfaces of 7075-T6 Al in 0.5N NaCl of (a) pH 2 and (b) pH 10.2,  $N_f = 10^6$ .

similar to those observed in neutral solutions (Fig. 11). Surface pitting, associated with inclusions, was also observed in the pH 2 solution although no secondary cracks were observed to be associated with pits (Fig. 12). Cathodically polarizing specimens to -1300mv vs SCE in NaCl solutions also resulted in the production of a featureless plus cleavage zone and, additionally a significant amount of Stage II, or non-crystallographic crack propagation was observed in regions far from the crack initiation site (Fig. 13-a). Polarization to -900mv vs. SCE also resulted in some grain boundary attack in regions removed from the initiation site (Fig. 13-b). Additionally, for cathodic potentials less than -900mv vs. SCE in either NaCl or  $\text{Na}_2\text{SO}_4$ , extensive secondary cracking and associated pitting was observed on alloy surfaces (Fig. 14-a). Optical metallography of cross-sections of the free surfaces indicated that the pits were associated with the cracks rather than being responsible for their formation due to stress concentrations, since sharp cracks also intersected the free surface adjacent to cracks which were associated with pits. Presumably these cracks formed late in specimen life since they are not extensively pitted (Fig. 14-b and c). Additionally, the blunted nature of the cracks on the specimen surface suggests that the cracks were broadened by a corrosion reaction.

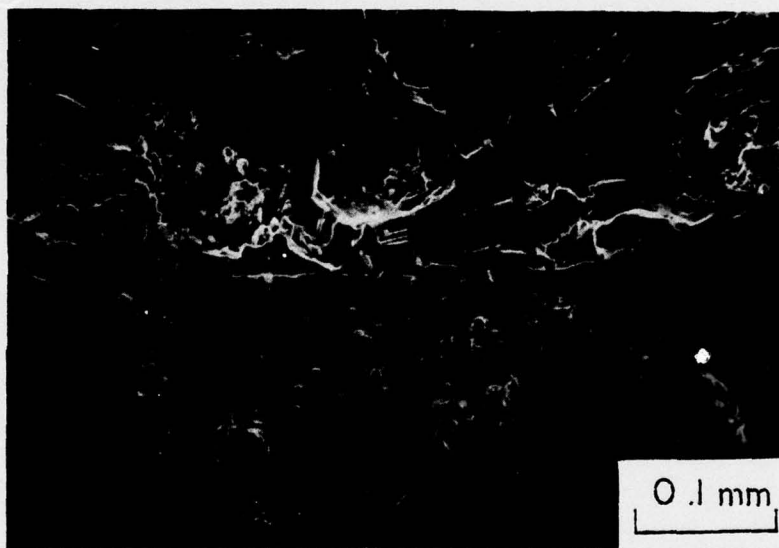
Fig. 12 Surface pitting of 7075-T6 Al in 0.5N NaCl solution of pH2.

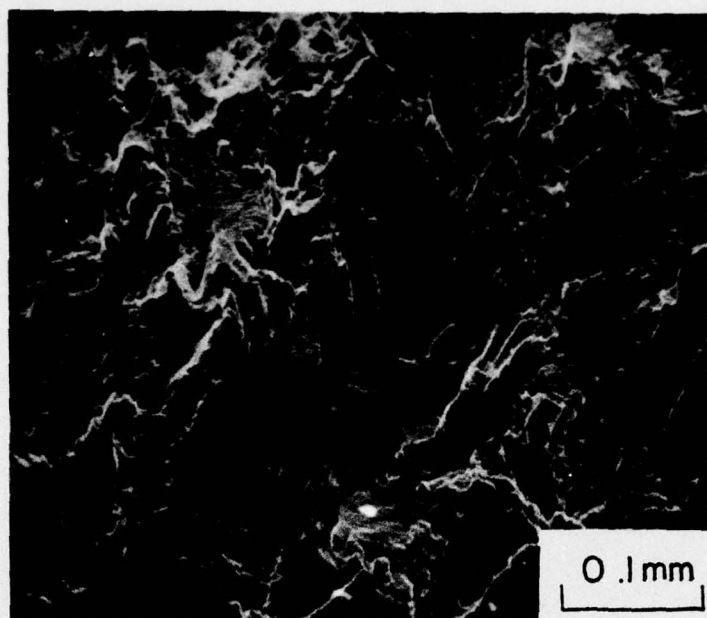
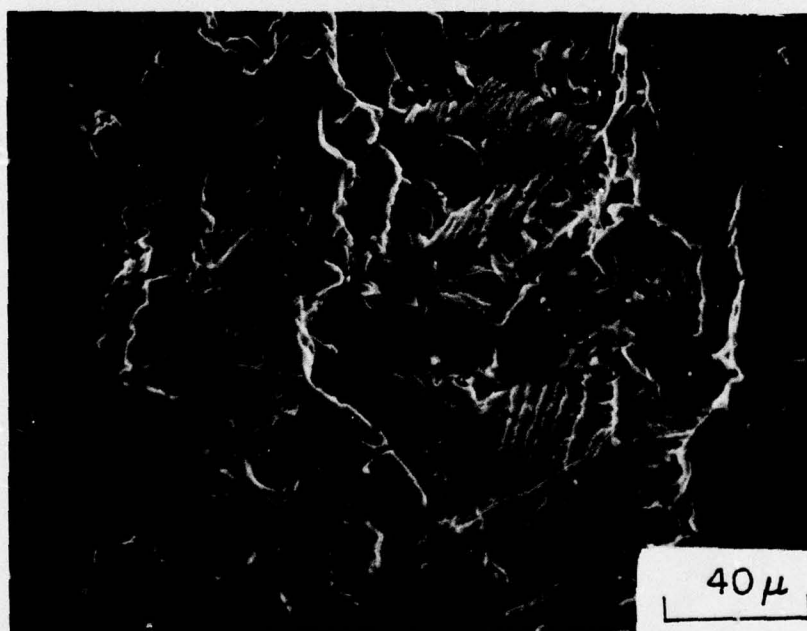
**Fig. 13** Fracture surface of 7075-T7 Al in 0.5N NaCl under conditions of cathodic charging (a)  $\phi_c = -1300$  mv vs. SCE showing Stage II cracking and (b)  $\phi_c = -900$  mv vs. SCE showing intergranular corrosion.

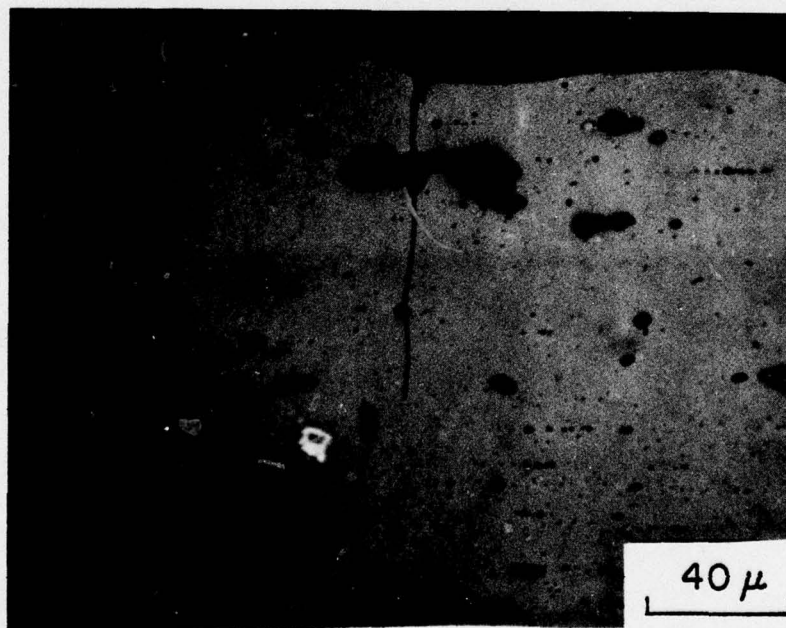
Fig. 14 (a) Secondary cracking and pitting of 7075-T6 Al alloy in 0.5N NaCl under conditions of cathodic charging at  $\phi_c = -1300$  mv vs. SCE, (b and c) optical micrographs of a cross-section of 7075-T6 alloy showing secondary cracking and pits associated with secondary cracks under cathodic charging conditions.
